Addendum

to original Supermal Karawaci Trial CT Report dated June 15, 2015
that was issued after 15 months of "electronic only" Cooling Tower (CT) water treatment

This Addendum covers extension to 32 months of continuous, daily operation of this
408 TR Kuken CT System that was selected for this trial that started on February 26, 2014.

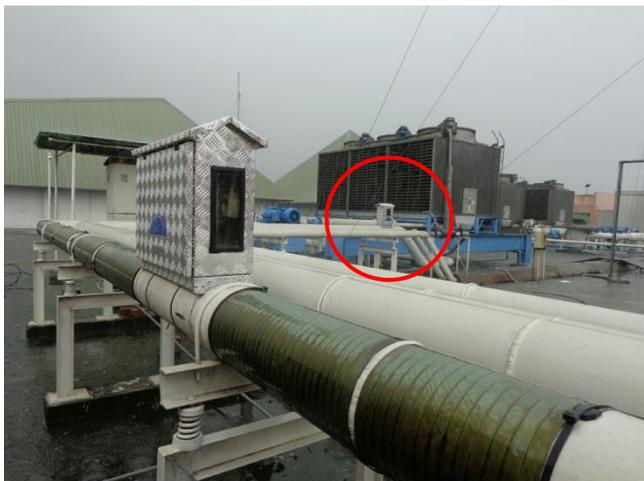
Photo: Vulcan impulse bands wrapped on either side of Vulcan Controller (located inside Aluminum box), with similar box housing the Controller of the Silver Copper Ionization system visible at rear (see red circle) near Cooling Tower.

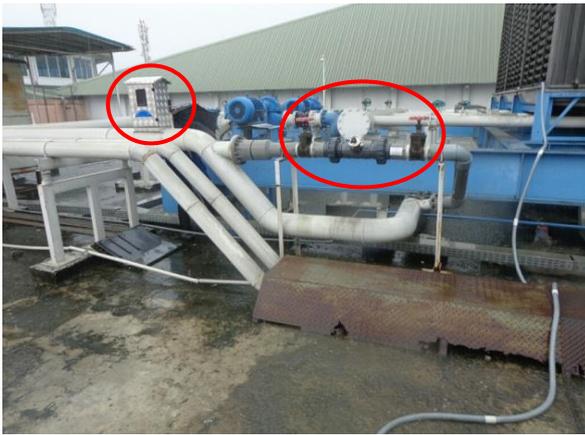
Above: (Large Circle) Ionization System in center of photo (see dark grey PVC piping mounted between two Red handled Isolating Gate Valves.
 Above: (Small Circle) Controller inside Aluminum Box mounted on CT piping and connected to Silver/Copper anodes.

Silver - Copper Ionization - Electronic Water Treatment (Algaecide & Bactericide) System.
 The anodes were removed and examined. Since this set was renewed at month 24 from start of the Trial, they still have 75% of mass (approximately 16 months) to go, before needing their next replacement.
 The anodes were found to have a bit of copper and calcium carbonate build up that was easily removed with water and rubbing the anodes with a brush or metal object.

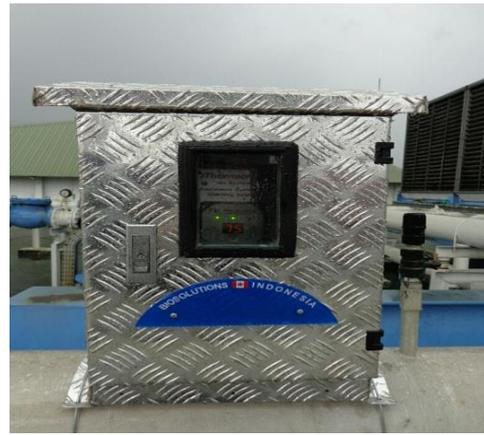
Above: Ionization Controller is visible behind the Glass panel in box.

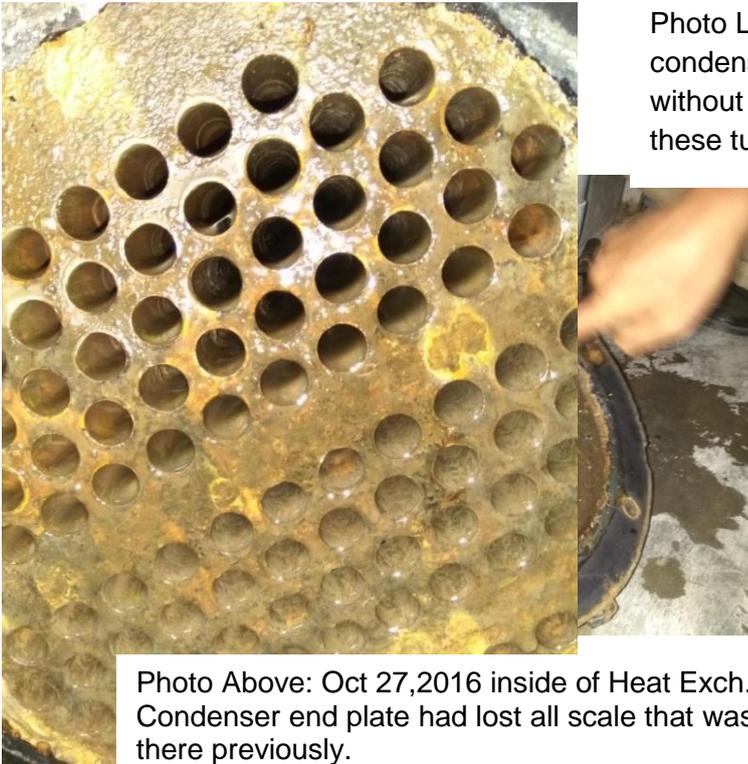
As shown in the photos that are part of this Addendum, the results - after 32 months of daily operation - remained very impressive. The condenser tubes were found to be very clean - like new copper pipes. The Mall Senior Building Inspector also drew our attention to the fact that at the last inspection test, the end plate had scale on its inner surface and that during this inspection he noted that the scale had completely disappeared. (see Oct 27 2016 photo of inside of end plate below).

Photo Left: Oct. 27, 2016 photo of ' clean as new ' condenser tubes after 32 months of operation - without any chemicals or blow down or cleaning of these tubes.

Photo Above: Oct 27,2016 inside of Heat Exch. Condenser end plate had lost all scale that was there previously.
(Light spot at bottom is reflected light).
