Case Study C. SKT Electronic CT Water Treatment

– latest report on heat exchangers tubes inspection with test

Report on Inspection and Test Results of August 3rd, 2017:

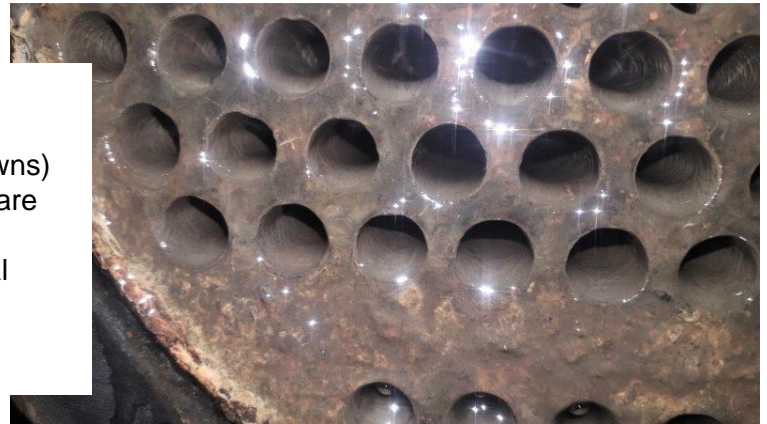
- See bottom of email for actual test results
- Inspection of HE condenser tubes showed complete absence of scale and rust
- No chemicals have been used to treat the CT water since installation in February, 2014
- No blow downs have taken place since installation
- Ph level shows moderately alkaline water. This minimizes the risk of corrosion in piping system
- EC reading was high at 1580. Note: this is of no concern with the Vulcan Scale and Rust control system, because the Vulcan unit electronically ‘modifies’ the structure of the scale-forming molecules – therefore rendering them incapable of attaching themselves to piping or to each other, with the result that the metal and mineral molecules circulate harmlessly in the CT water.
- No scale also means that bacteria have fewer places to grow and thrive
